Regarding: Additional Geotechnical Engineering Services
Port of Port Orford Redevelopment
300 Dock Road
Port Orford, Oregon
PBS Project 73422.000

PBS Engineering and Environmental Inc. (PBS) is pleased to submit this letter report summarizing additional geotechnical engineering services for the proposed Port of Port Orford Redevelopment project located off Dock Road at Graveyard Point in Port Orford, Oregon. The general site location is shown on the Vicinity Map, Figure 1. The locations of existing site features is shown on the Site Plan, Figure 2.

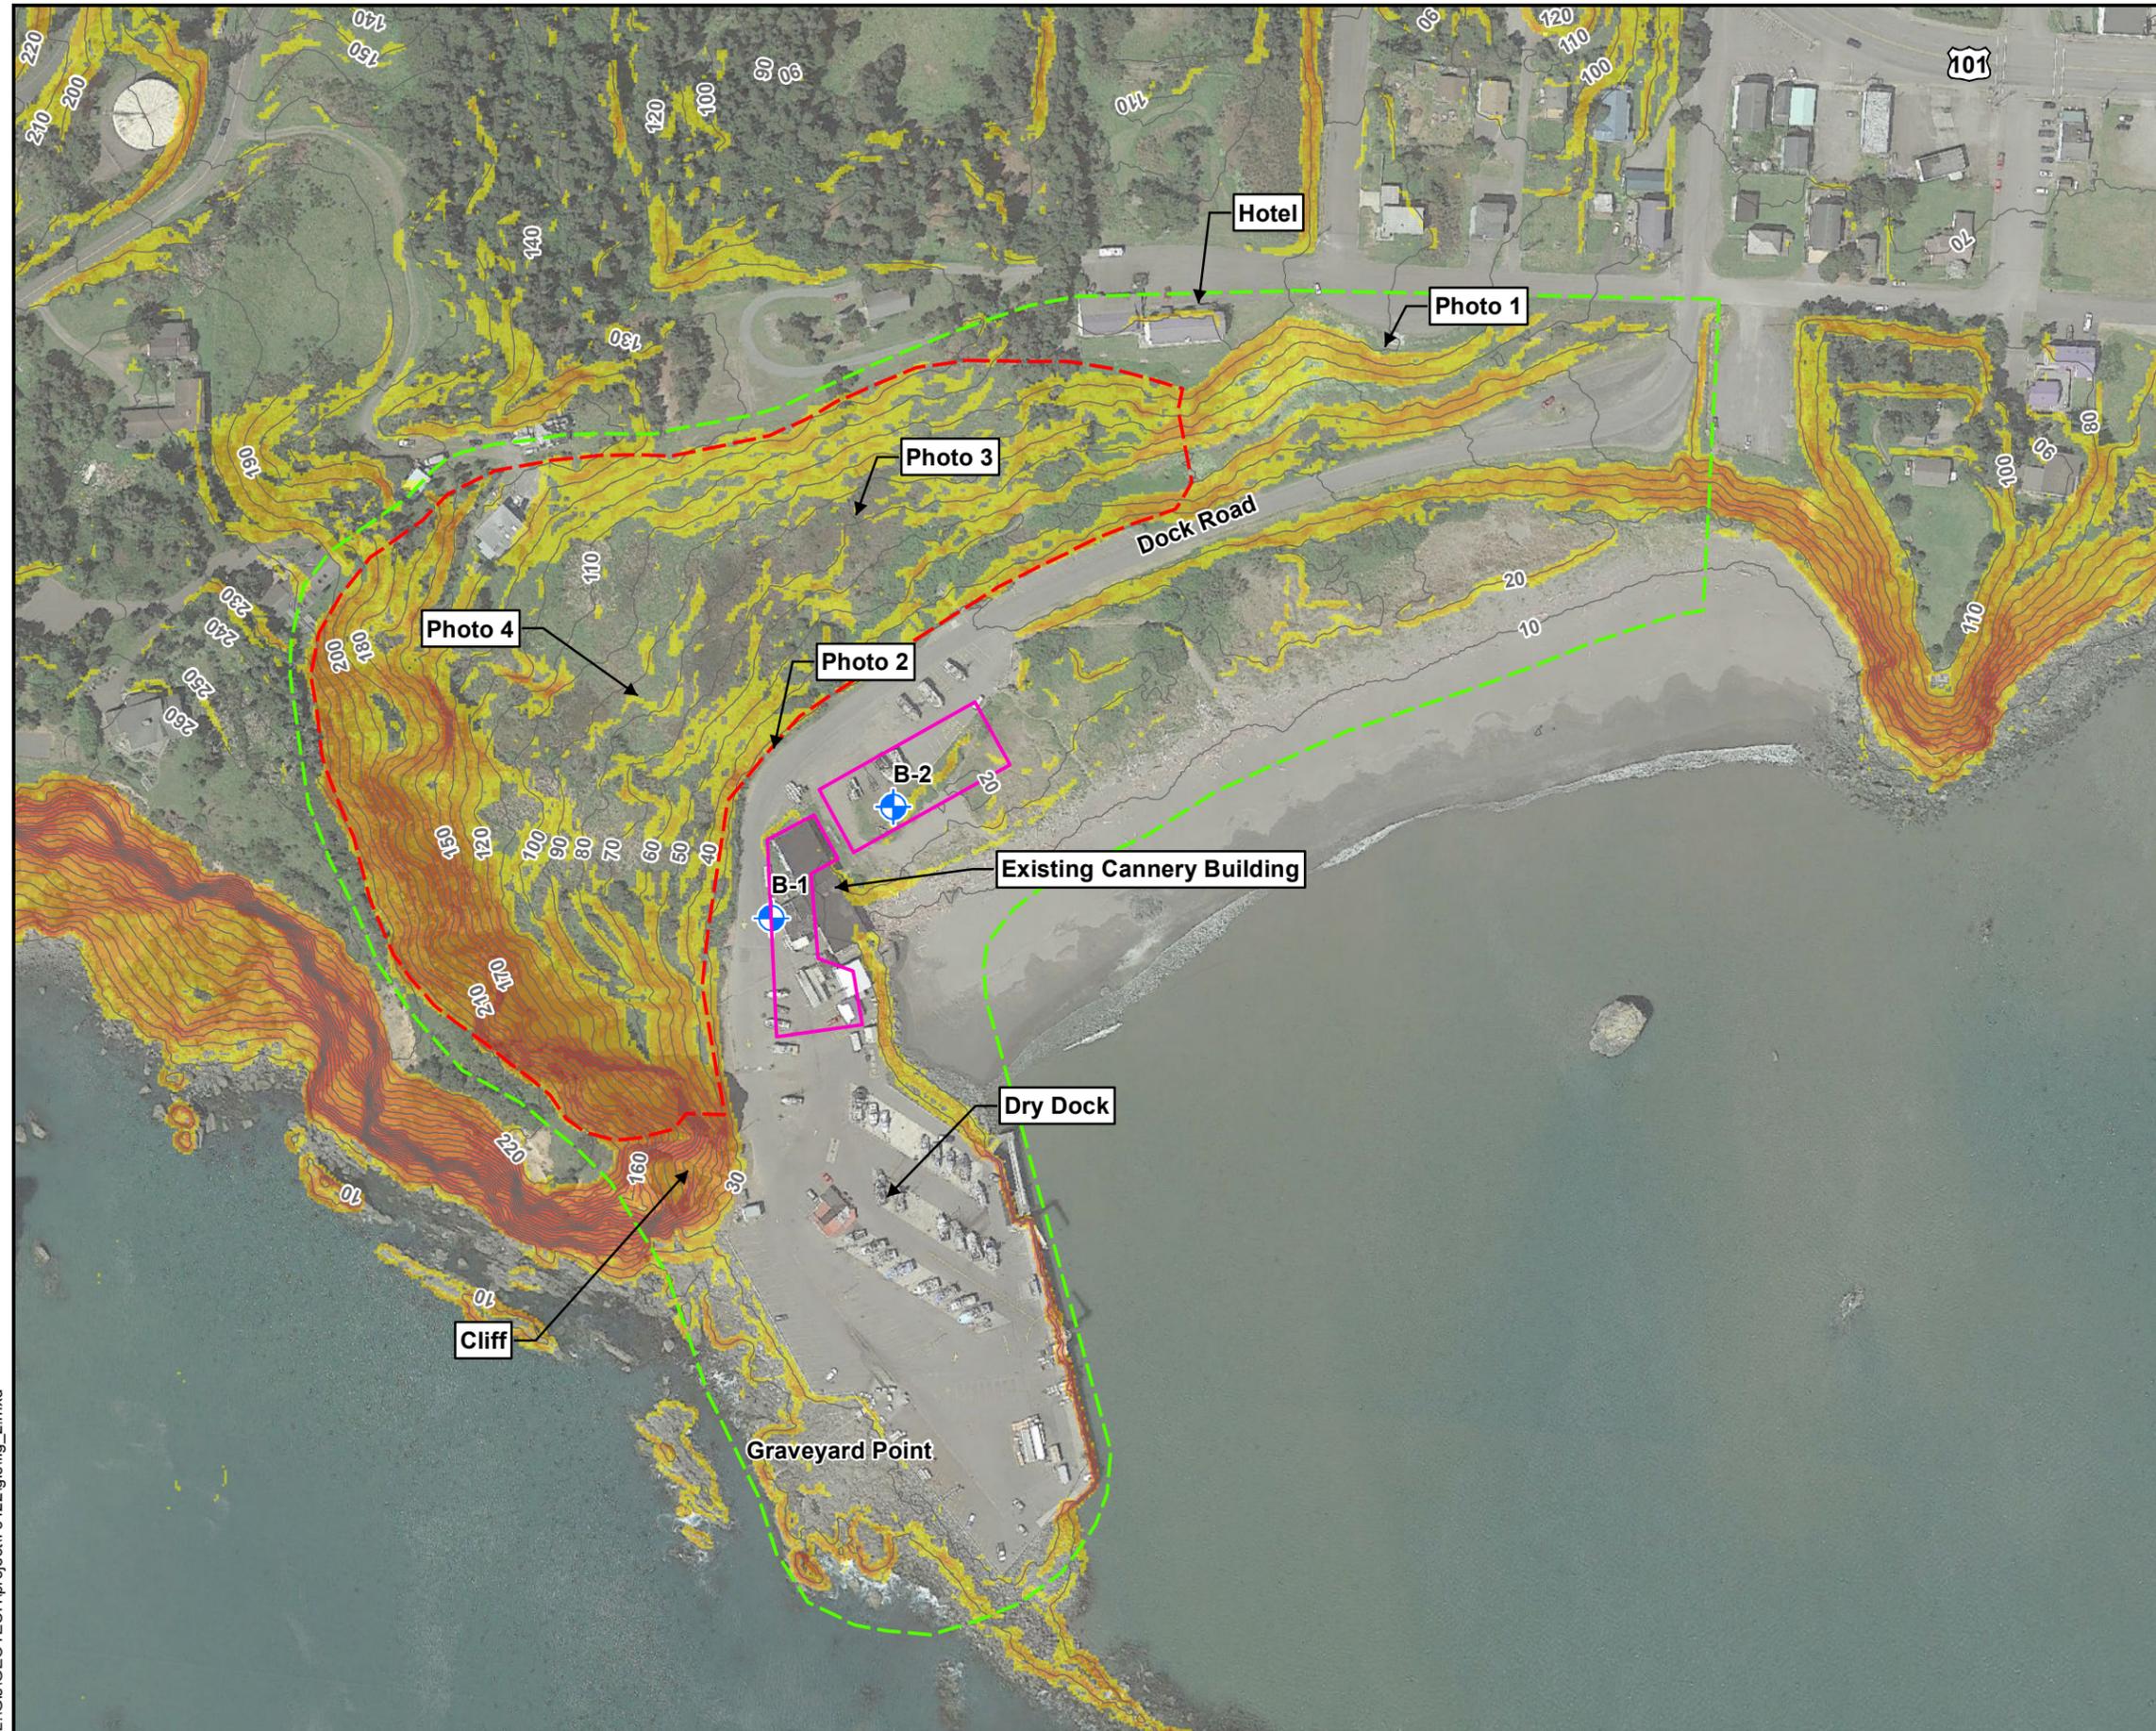
SITE PLAN

The hillside along Dock Road is convex shaped, with a hummocky surface and a steep, well-defined head scarp readily distinguishable by the inclination of slope (Figure 2). Some of the hummocks form steep fronts, with slope inclination upward of 27 degrees (Figure 2). The hillside is vegetated by grass, brush, and small trees, with some low-lying areas located near the center of the slope and between hummocks.

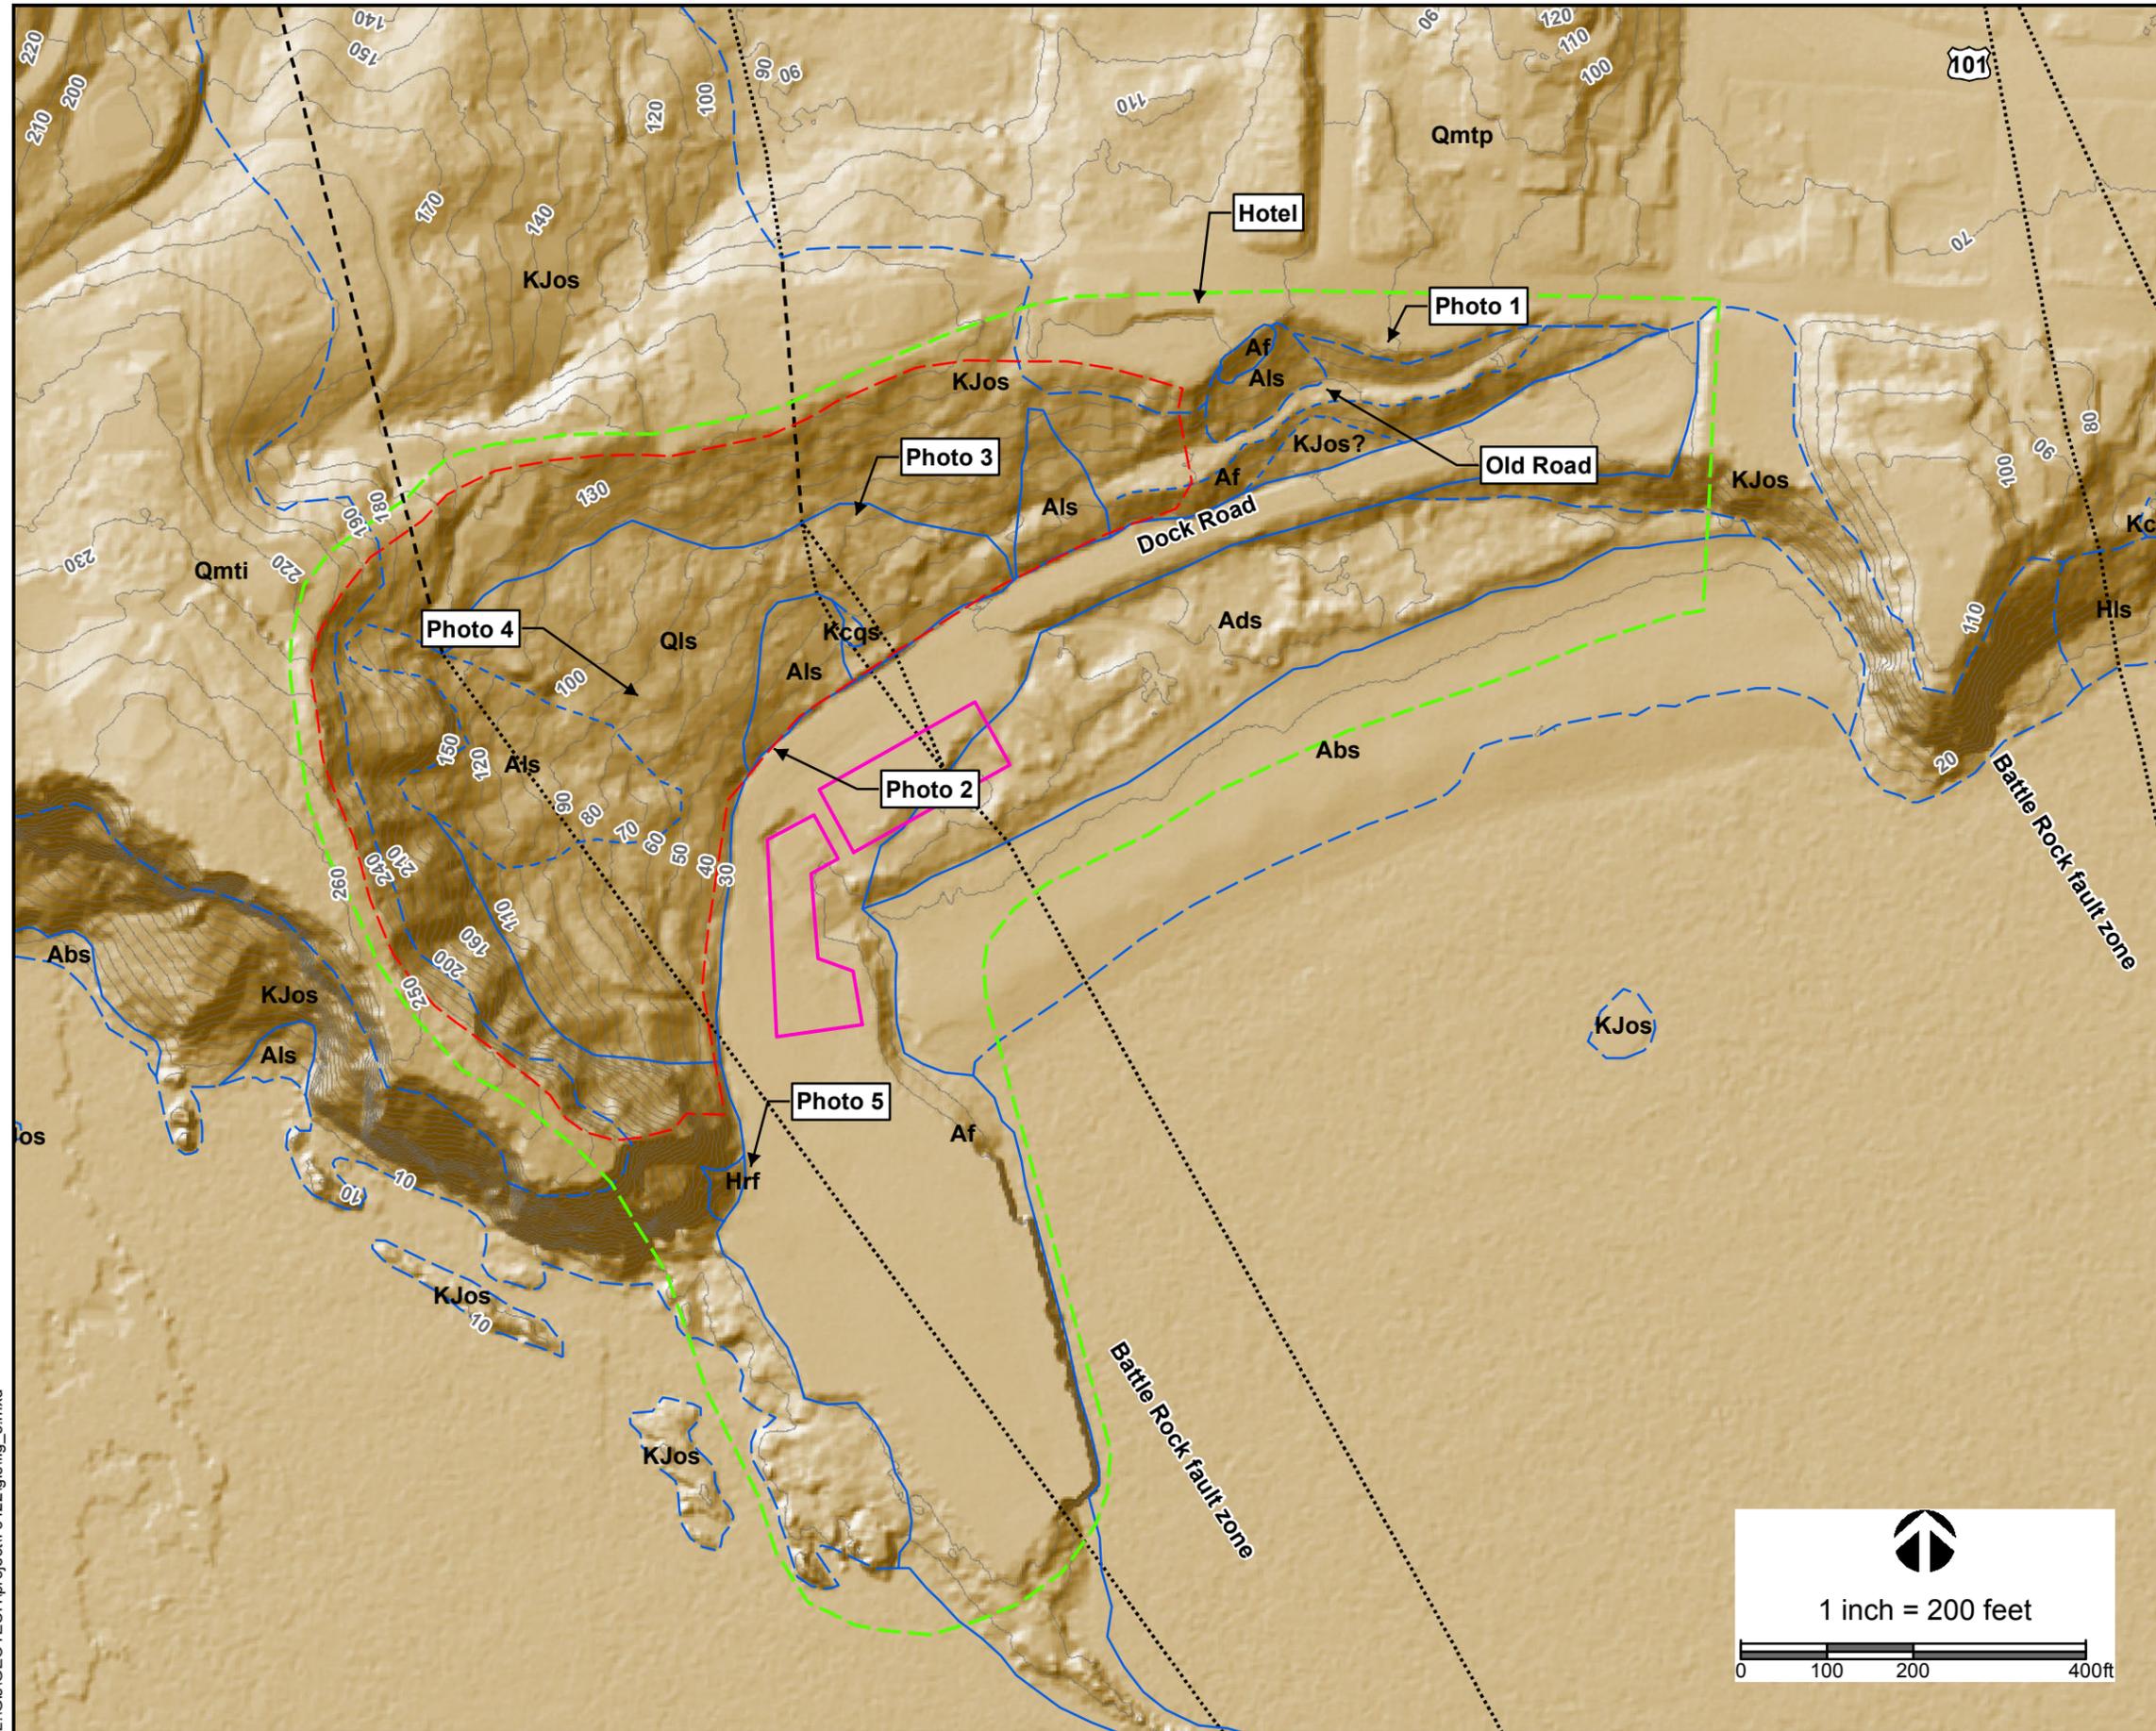
GEOLOGIC MAP

Dock Road is located between a mapped landslide deposit (map unit Qls) forming the convex hillslope to the north and west of the road, and beach and dunes (map units Ads and Abs) to the south (Figure 3).⁵ Map unit Qls is the largest landslide within the site and contains several smaller Anthropocene age landslide deposits mapped within it (map unit Als). Burns et al. (2014) identify this landslide as historical or active, with movement less than 150 years ago or currently moving, and classify this slide as a rock flow. We herein adopt the title of this slide as "rock flow" and assume all Anthropocene landslide deposits mapped by McCloughry et al. (2013b) are active slides, as identified by Burns et al. (2014), unless engineered measures have been implemented or monitoring has proven otherwise.

Additional fill may exist along the north side of Dock Road at the eastern end of the road. At this location, the geometry of the slope relative to Dock Road and the old road suggest that the old road was cut into the hillside and the excavated material was pushed downslope. This fill was mapped with an inferred contact (Figure 3).

The gravel fill near the hotel was placed at the head of what PBS has interpreted as an active slump. The slump consists of a hummocky surface with a distinctive distal edge located along the old road (identified in Figures 3 and 4), and freshly exposed soil free of vegetation was observed along the western flank. This feature was mapped by PBS (map unit Als) with an approximate contact and can be found on Figure 3.

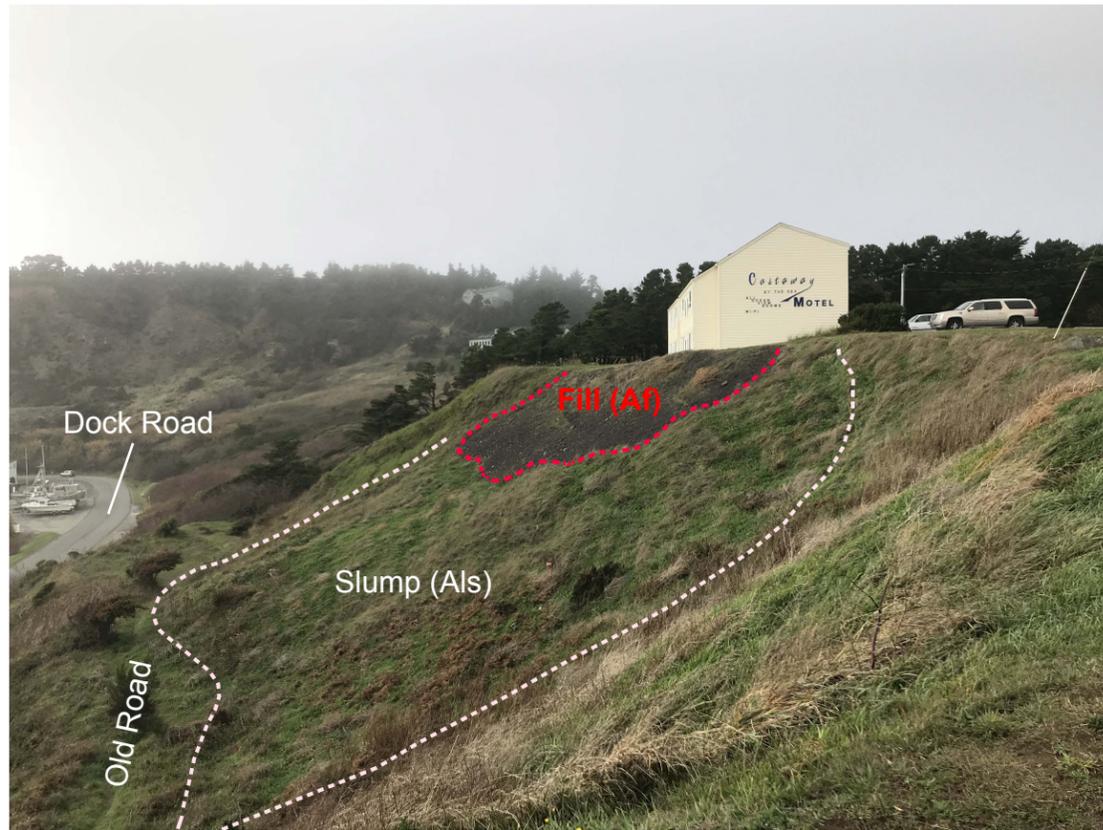
Fill was observed near the Castaway by the Sea hotel located above the Dock Road (Figure 4, photo 1). The fill was placed at an undermined date and consists of angular, 1- to 4-inch diameter sandstone gravel. The crest of the fill was at the same grade as the surrounding ground surface at the time of our visit. The fill was mapped (map unit Af) with a known contact (Figure 3). Corrugated pipes were observed along the slope below the fill and across the old road. To where these pipes extend is unclear, and we are uncertain whether these pipes are part of an improvised dewatering system or some sort of stormwater drainage for the hotel.

- Fill placed at the hotel
 - Gravel fill was placed at the top of the slope by the hotel above what PBS has identified as an active slump.
 - It appears that the fill placed at the top of the slope did not include efforts to buttress or stabilize the slide mass upon which it was placed, and we interpret this to be an unengineered repair.

Photo 1: Undocumented fill and slump with evidence of recent creep

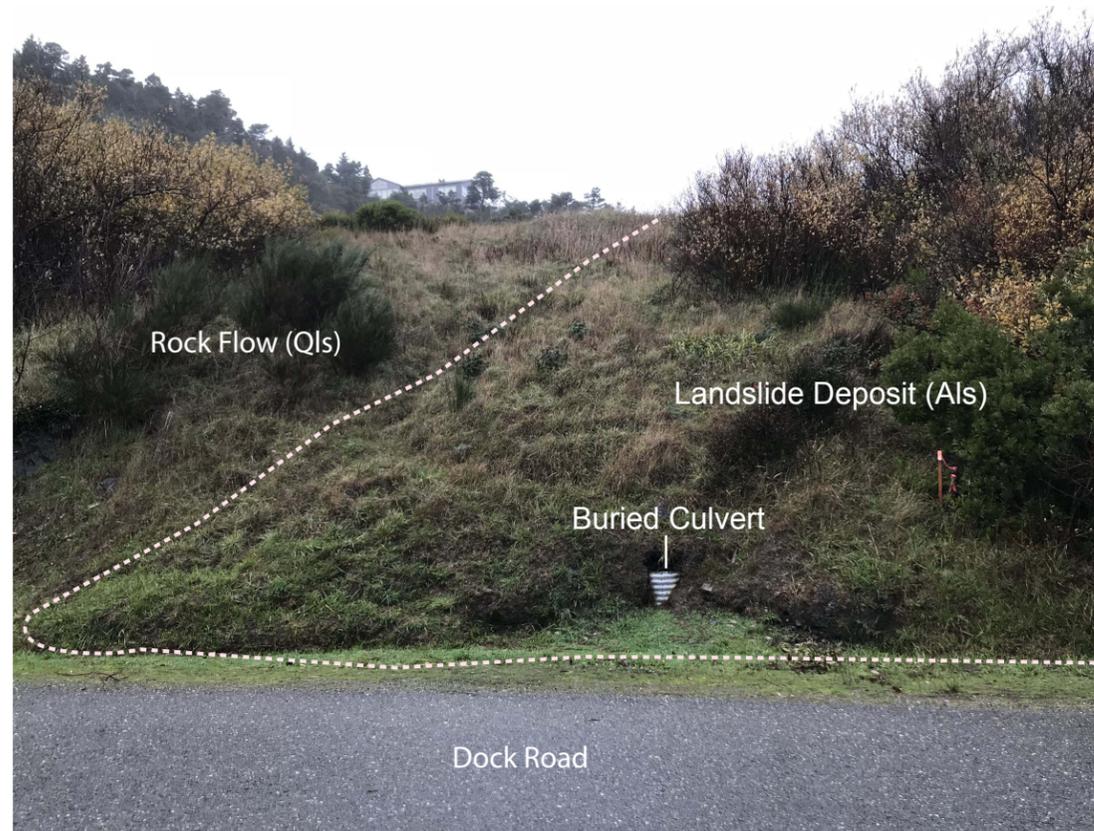
Immediately north of the existing cannery building, a vertical, corrugated pipe was observed protruding out of the toe of the hillside (Figure 4, photo 2). The purpose of this pipe is unclear. However, it appears it is being "slowly engulfed" within a soil mass from up slope and periodically cleaned. This location was in proximity to an Anthropocene age landslide (map unit Als) by McClaughry et. al (2013b). As such, we have modified the extent of the Als boundary in Figure 3 to include the area identified in Figure 4, photo 1.

Photo 2: Toe of mapped Als landslide with evidence of recent creep

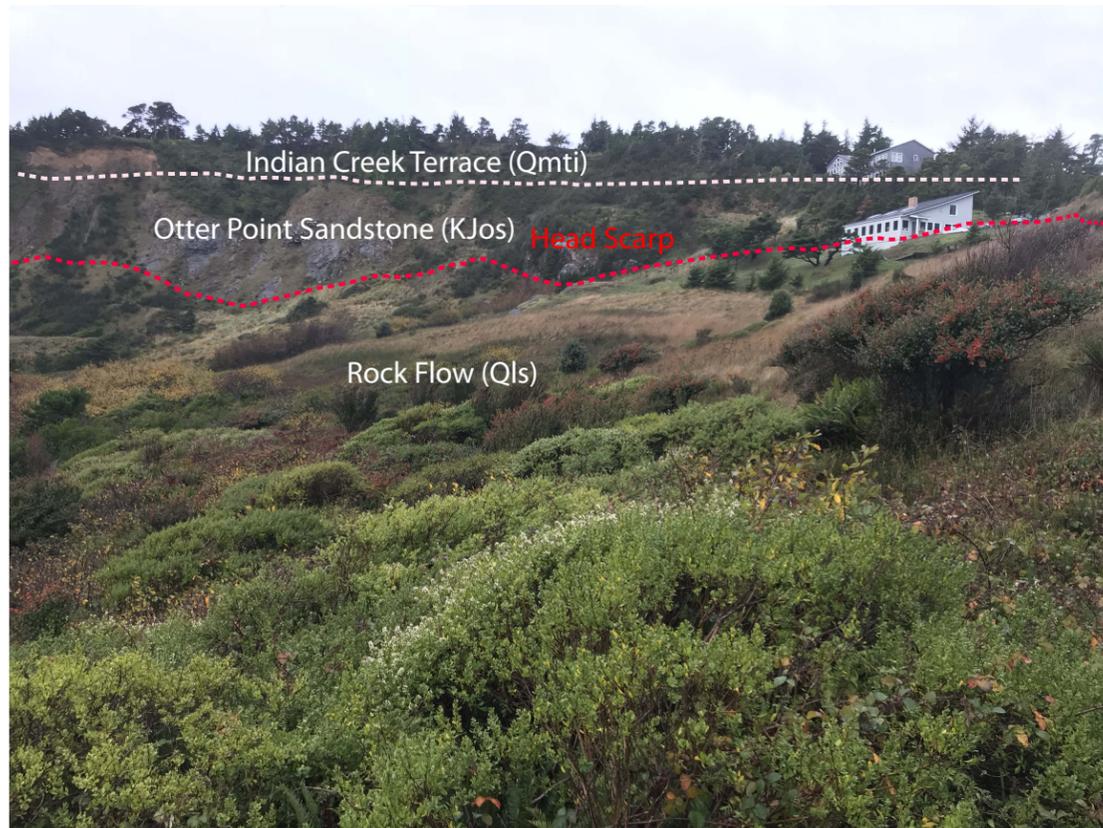
Traversing the rock flow proved to be difficult due to thick vegetation (Figure 4, photos 3 and 4). Lower-lying areas were overgrown with dense Equisetum (commonly known as horsetail or snake grass) and teasel, and the ground surface had a soft, spongy feel underfoot that may be indicative of shallow groundwater or seasonal springs. We note that no surface water or seepage was observed at the time of our site reconnaissance. In the center of the mapped rock flow, hummocks had the same ground feel and vegetation as the low-lying areas (Figure 4, photo 4). No visible surface features indicative of recent slope movement (e.g., tension cracks, potholes, exposed soil, etc.) were observed while traversing the rock flow. However, we note that this does not exempt the rock flow from being classified as active.

Photo 3: Westward view of rock flow

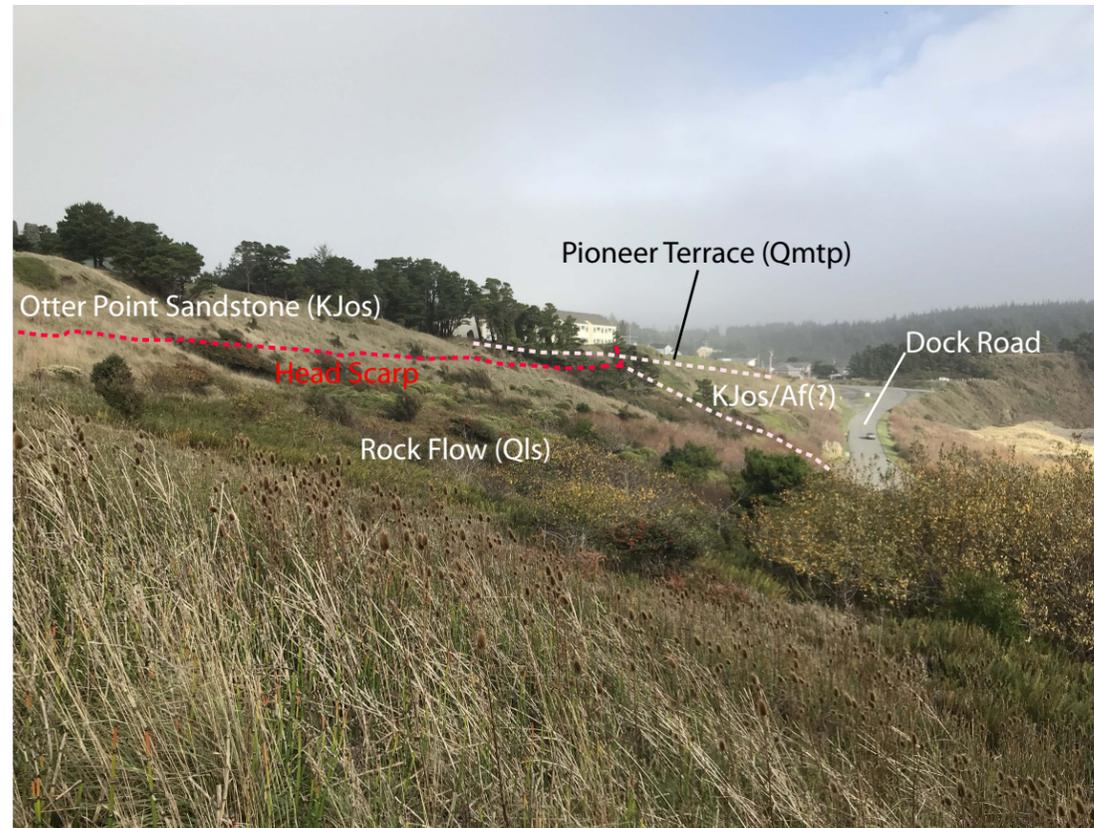
Photo 4: Eastward view of rock flow
