# Port Orford Jetty, Oregon 2010 Bathymetry/Topography

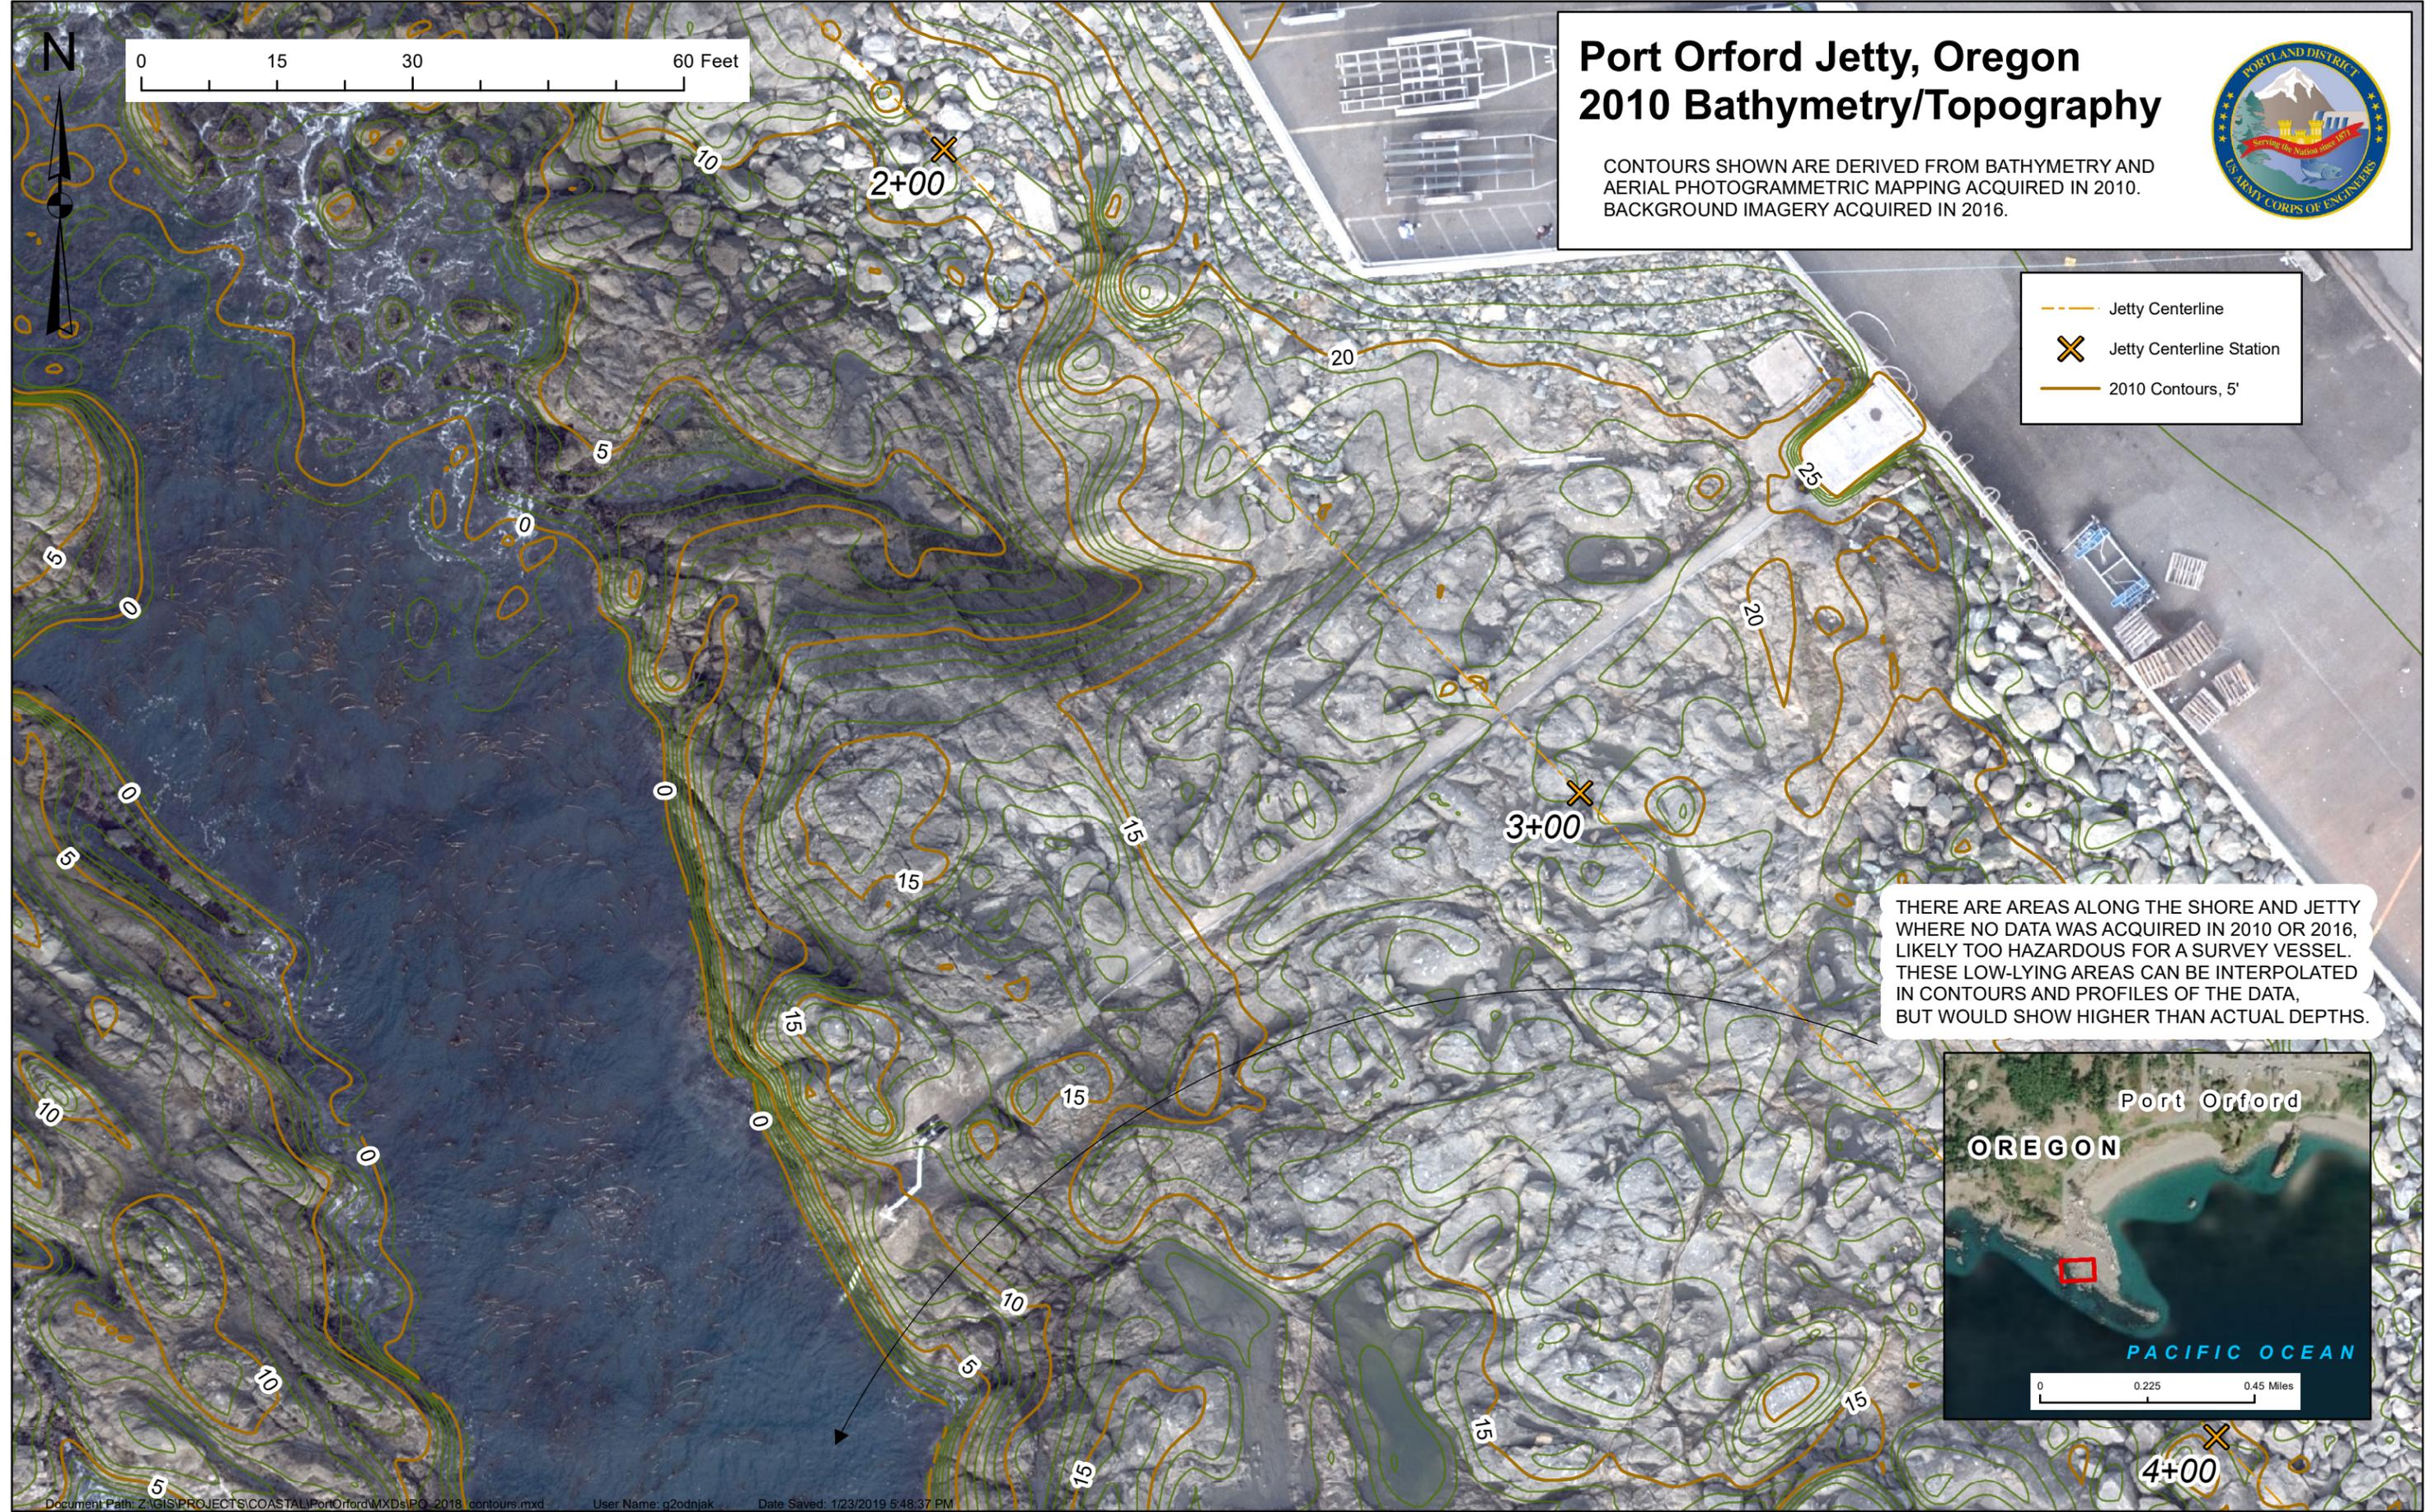
CONTOURS SHOWN ARE DERIVED FROM BATHYMETRY AND AERIAL PHOTOGRAMMETRIC MAPPING ACQUIRED IN 2010. BACKGROUND IMAGERY ACQUIRED IN 2016.

THERE ARE AREAS ALONG THE SHORE AND JETTY WHERE NO DATA WAS ACQUIRED IN 2010 OR 2016, LIKELY TOO HAZARDOUS FOR A SURVEY VESSEL. THESE LOW-LYING AREAS CAN BE INTERPOLATED IN CONTOURS AND PROFILES OF THE DATA, BUT WOULD SHOW HIGHER THAN ACTUAL DEPTHS.
