## Port of Port Orford

## Ports 2022-2027 Mitigation Actions

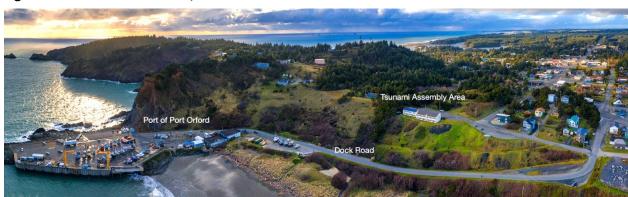
Figure I-13. Port of Port Orford, Aerial View.

The Port of Port Orford is located 75 miles north of the California border in north Curry County. The port is situated just south of Port Orford headland on the open ocean. As such, it is an open-water dock with no natural protection from a bay or jetty and boasts the title of being the only dry-dock port on the West Coast. The Port of Port Orford harbor that has been in use since the 1850s and was primarily used for shipping lumber. The first Port District was formed in 1911 and dock construction began in 1919. A breakwater was built in 1971 in an attempt to protect the dock from winter storms. Shoaling became a problem shortly after and dredging became necessary. Although no longer a deep harbor, Port Orford is still home to many commercial fishermen and is used as a harbor of refuge by many during severe storms (Port Orford, 2021).

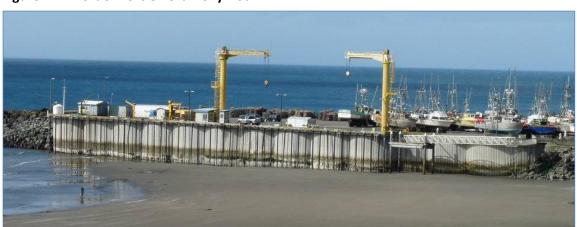
Figure I-14. Port of Port Orford Dolly Dock

Fishing boats and other vessels are lifted in and out of the water by cranes operated by port staff. The boats are then set upon custom-made dollies and parked in rows on the dock. As a result, it is known as a "dolly dock".

Source: Port of Port Orford, June 2012. Notes: 1. See boats and cranes on dock itself. 2. Shoaling of the harbor as seen at minus tide, showing dock sheet pile construction and aging high-capacity cranes used to launch and retrieve vessels.
